# **Phase I Environmental Site Assessment for the Proposed Walnut Energy Center**

**69-Acre Parcel  
600 South Washington Road  
Turlock, California**

**Phase I Environmental  
Site Assessment**

**September 2002**  
**Document Number 08727-103.100**

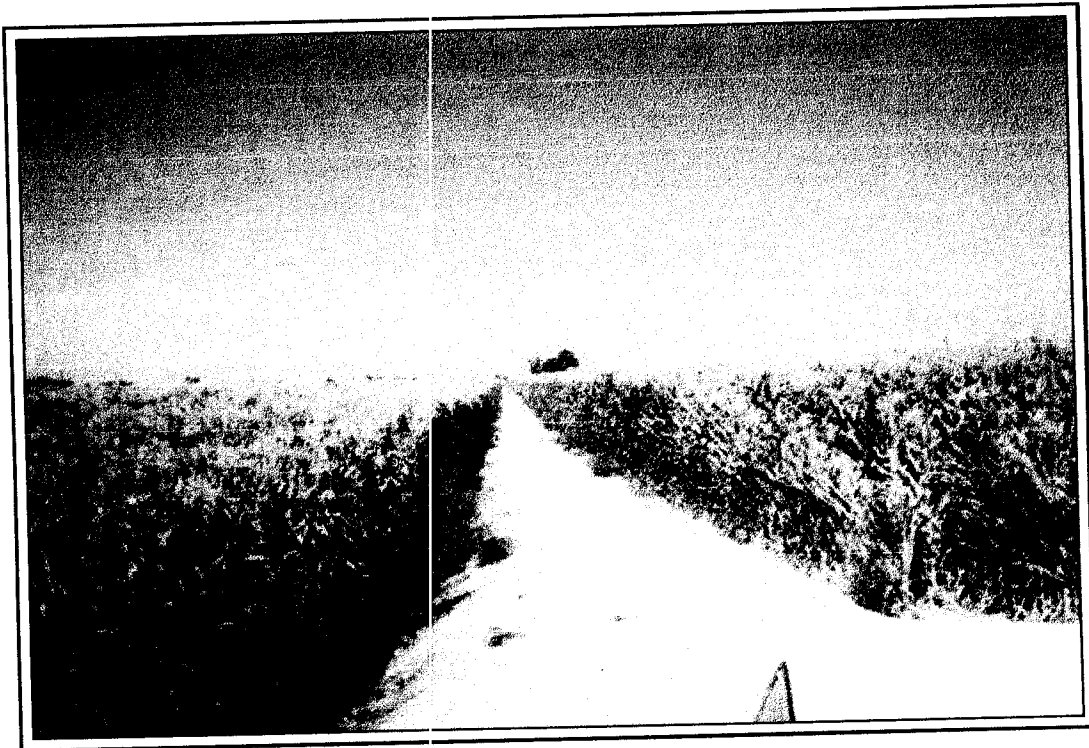
Photo 4: Looking north along unpaved road running through middle of Subject Property.

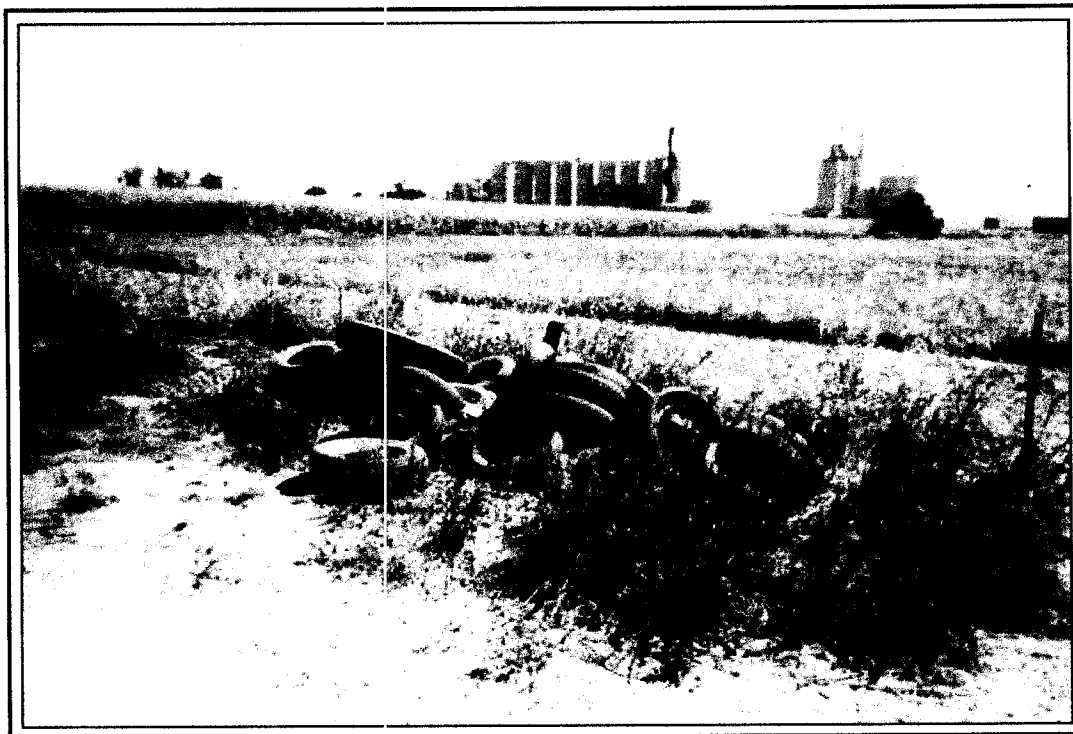
Used automobile tires were observed in the northeastern corner of the property. At the time of the site visit, there was no evidence that the Subject Property was utilized for large scale, open-dumping of solid waste.

Photo 5: Used tires in northeast corner of Subject Property.
